Kenya's huge railway project is causing environmental damage. Here's how

Kenya is constructing a railway line that connects the coastal port of Mombasa and the interior of the country. It is expected to terminate at Malaba, a town on the border with Uganda, and link up with other railways that are being built in East Africa. It's locally known as the Standard Gauge Railway (SGR).

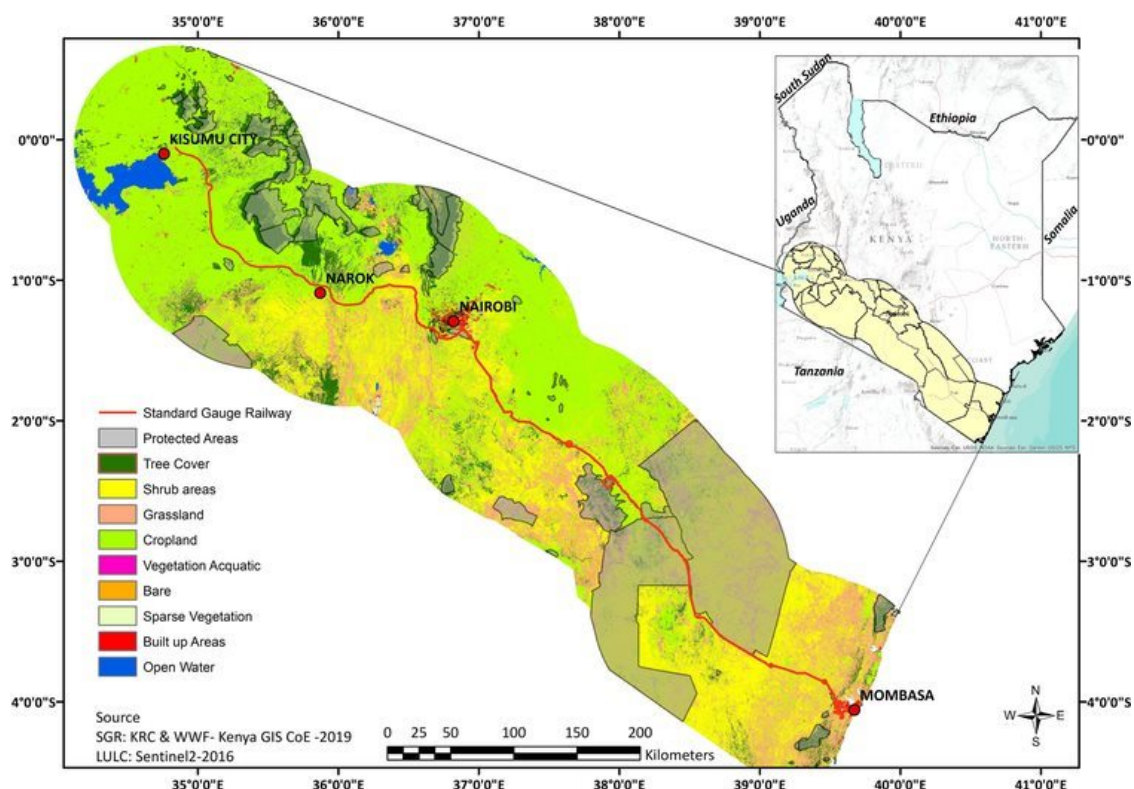
Map of the railway corridor.

The construction of the railway is being done in three phases. The first two phases (now completed) cover 610km. The third phase is still under construction. Our study focused along the entire stretch of the first two phases, covering eight counties

from Mombasa to Narok.
