Kenya's huge railway project is causing environmental damage. Here's how

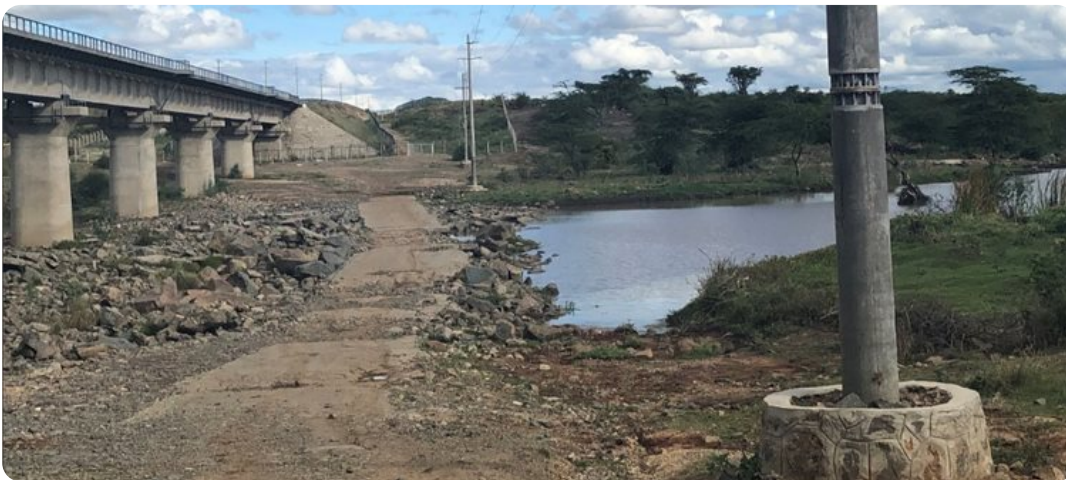
A blocked river in Kitengela.

In addition, silt from construction led to the blockage or drying up of rivers, notably the Empakasha and Mbagathi rivers around Nairobi. Most communities in these areas rely on the rivers for domestic consumption, watering their livestock and irrigation agriculture.
